# NAVAL POSTGRADUATE SCHOOL

# THESIS

THE EFFECTS OF MULTIPATH PROPAGATION  
ON THE RANGE MEASUREMENT SYSTEM  
AT FORT HUNTER LIGGETT

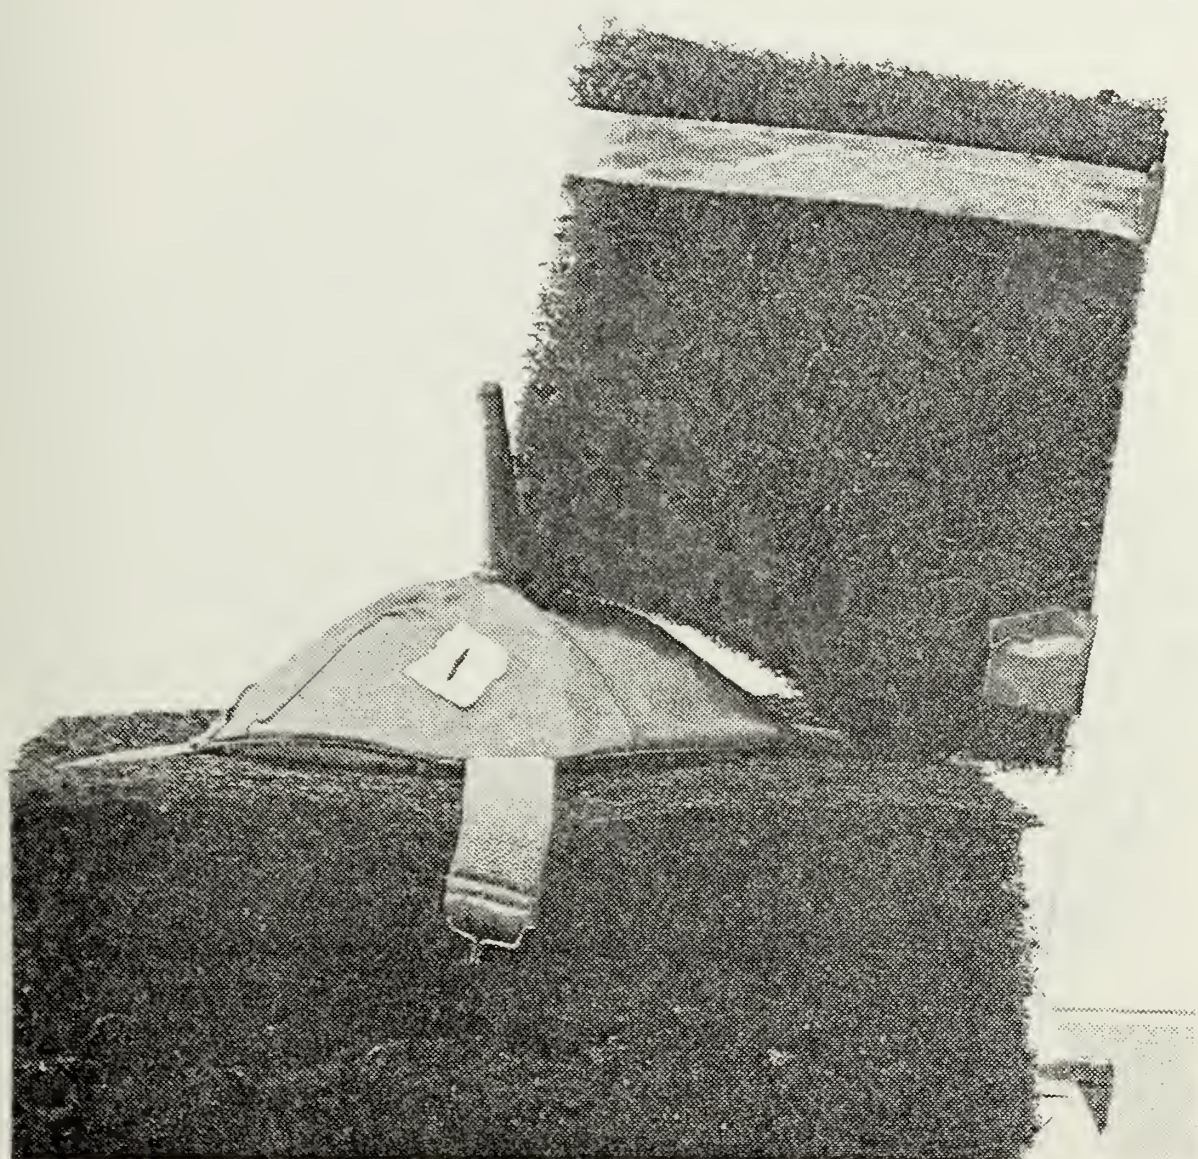
Figure 76 - FIELD CONFIGURATION B
